PROJECT DESCRIPTION

Björkdalsgruvan AB
Mandalay resources

Björkdal

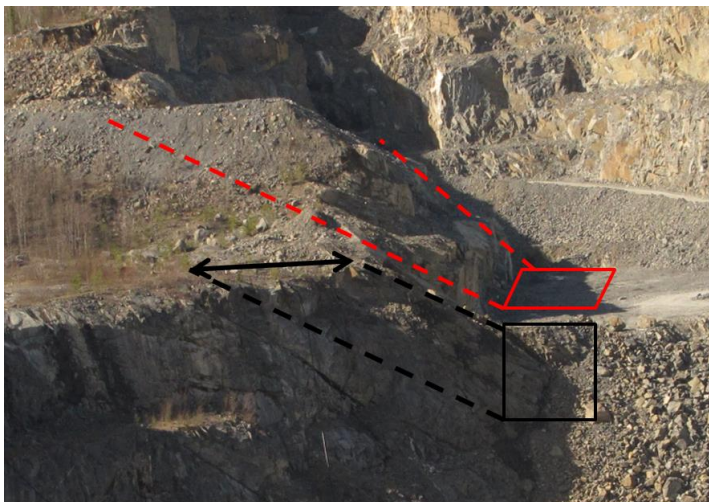
Itasca Consultants AB supported the mine with rock mechanics advice for the bench stability issue. Itasca visually inspected the site for stability assessment and provided an extraction sequence in order to ensure safe working conditions in the area. Itasca evaluated if different types of failure could occur within the slope, and concluded that the most likely failure was planar.

Area where the failure occurred.

The work resulted, primarily, in advice on how to safely remove the loose material to ensure safe working conditions for personal down in the pit. The planar failure intersected the upper bench and the conclusion was that the joint causing the planar failure only will affect the upper part of the slope (i.e., the top 1-2 benches). It was also concluded that the overburden above the benches had to be stripped in order to ensure safe working conditions in the pit. The removal of the loose material went successfully and mining has continued in the area.

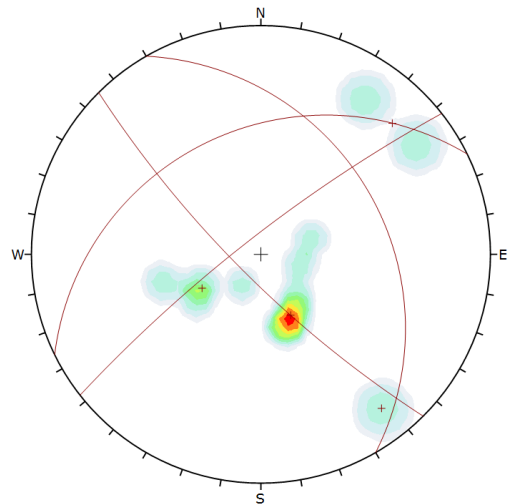
Stereographic projection showing joints in the area.
